2023-27 AQUATIC PLANT MANAGEMENT PLAN

SAND BAR & TOMAHAWK LAKES
BAYFIELD COUNTY
WDNR WBICS: 2494900 & 2501700

July, 2022

TOWN OF BARNES & FRIENDS OF
THE EAU CLAIRE LAKES AREA
BARNES, WI

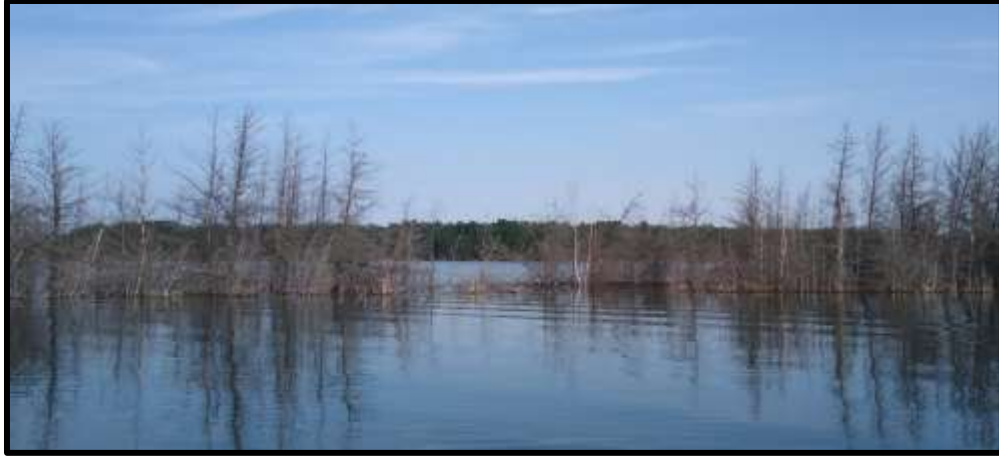
Figure 1: Flooded sandbar looking from Tomahawk Lake to Sand Bar Lake taken on 8/31/21 by Megan Mader – LEAPS

After enjoying a separation of the two lakes for a decade or more due to low water conditions, around 2018 water levels increased to the point where surface water moves freely between the two lakes (Figure 1). This rapid increase in water level also left a ring of submerged small trees and shrubs, now dead almost all around both lakes. The lakeside water depth where these submerged trees and shrubs begin is between 5 and 7 feet of water. From the dry shoreline, the ring of submerged trees extends some 10-20 feet into the lake.

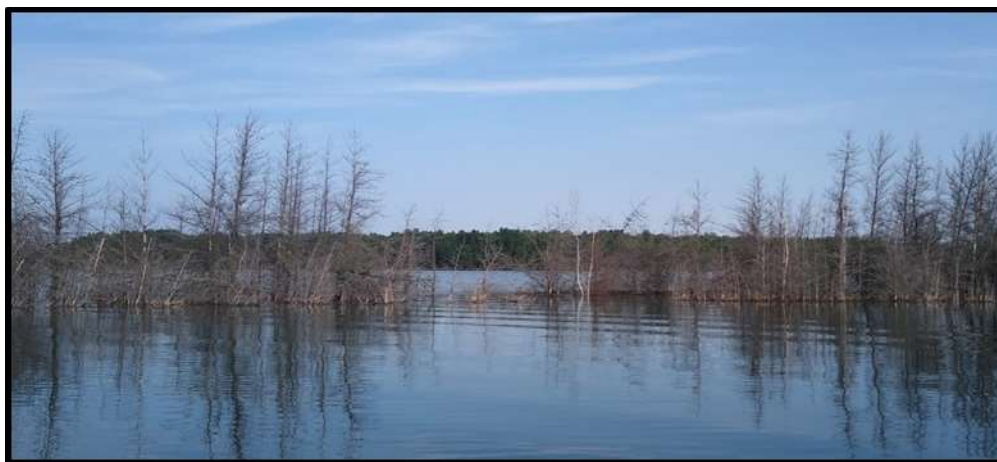
Figure 9: Coarse woody habitat under high water conditions in Sand Bar and Tomahawk Lake (photo taken by Megan Mader on 8/31/2021)

Much of the coarse woody habitat around both lakes is due to high water inundating shoreland woody shrubs and small trees in the nearshore area (Figure 9). The coarse woody habitat created by this source changes with the water level - high water creates more, and low water creates less. The amount of larger coarse woody habitat, the kind created when large trees fall into the lakes, has never been inventoried. After such a survey has been completed, property owners may consider the addition of coarse woody habitat through the installation of Fishsticks. Fishsticks are created by using whole, live trees that are cut down and installed along the shoreline. In most cases, 3-5 40-60ft trees are stacked on top of each other and fastened to the shore. Fishsticks installation is usually completed in the winter when there are good ice conditions that support the use of large equipment (skid steers and trucks).

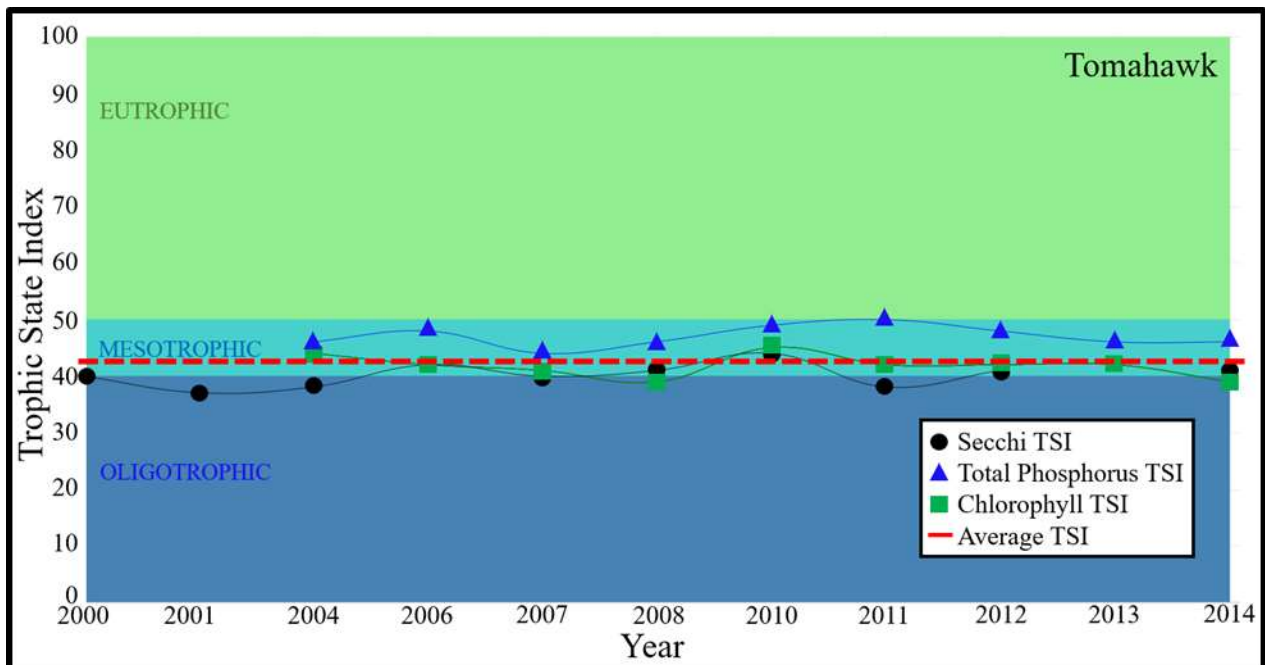
Figure 12: Tomahawk Lake, Bayfield County Trophic State Index (WDNR 2022)

In Tomahawk Lake, the same water quality measurements were recorded from 2000-2015 and produced similar results. However, Tomahawk's water clarity is not as good as Sand Bar's, resulting in the lake being classified as more mesotrophic despite comparable levels of TP and Chl-a (Figure 12). This may be a result of greater dissolved organic materials – or tannins – entering the lake from the small catchment area and staining the water. It may also be caused by nutrients running off from the park and boat launch in conjunction with greater boat traffic on Tomahawk stirring up bottom sediments. More information on Tomahawk's water quality can be found at: <https://dnr.wi.gov/lakes/waterquality/Station.aspx?id=043119>

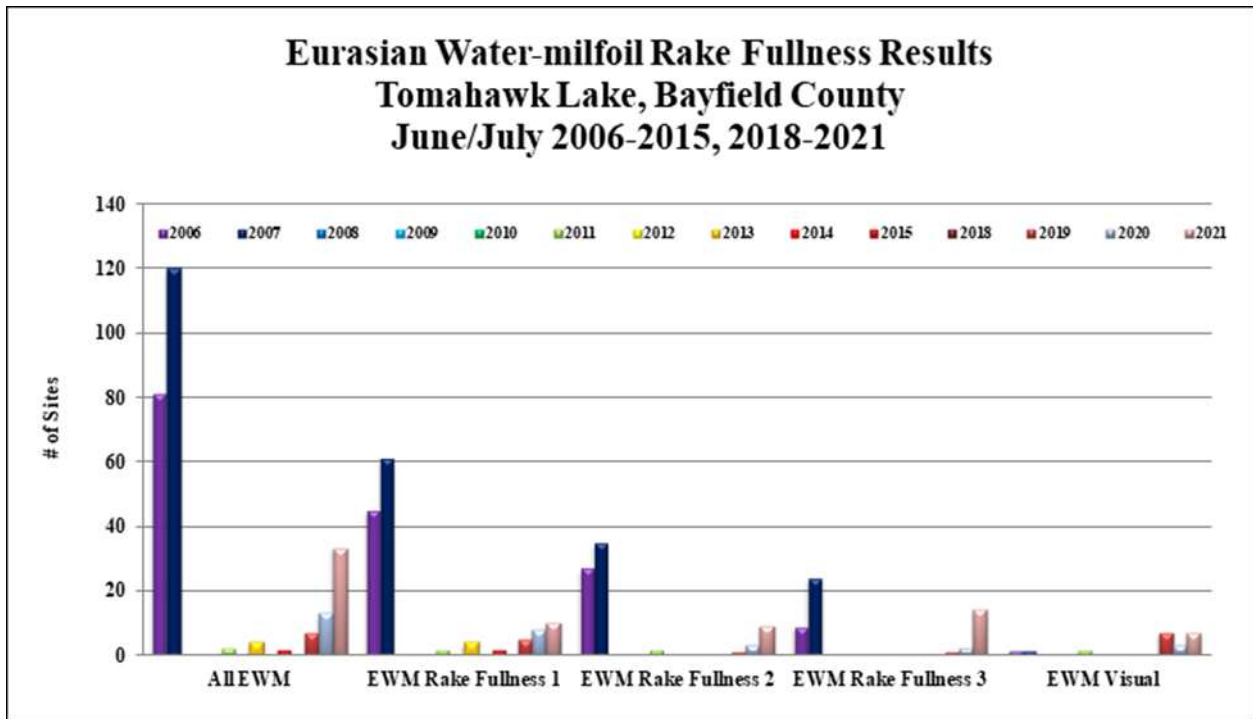
Figure 16: EWM rake fullness results 2006-2015, 2018-2021 (Berg, 2021b)

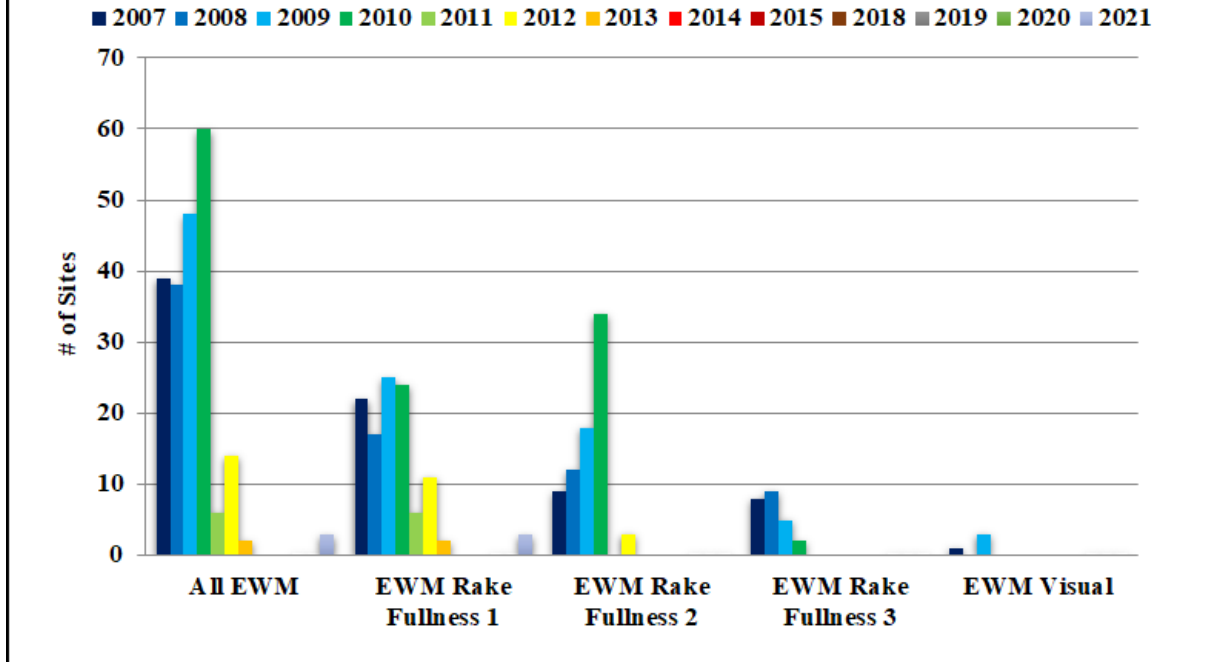
Figure 24: EWM rake fullness results 2007-2015, 2018-2021 (Berg, 2021a)

Eurasian Water-milfoil Rake Fullness Results Sand Bar Lake, Bayfield County July 2007-2015 and 2018-2021

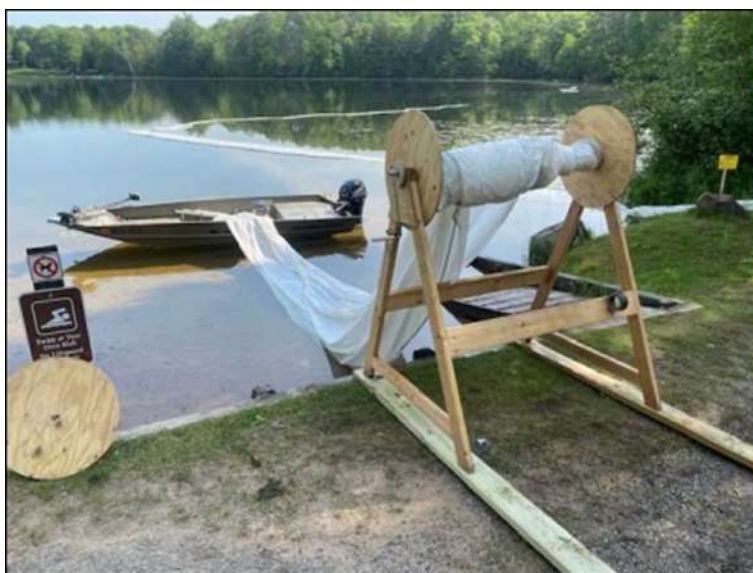
Figure 37: Limno-curtain material on a roll before installation (photo from Marinette Co. LWCD)

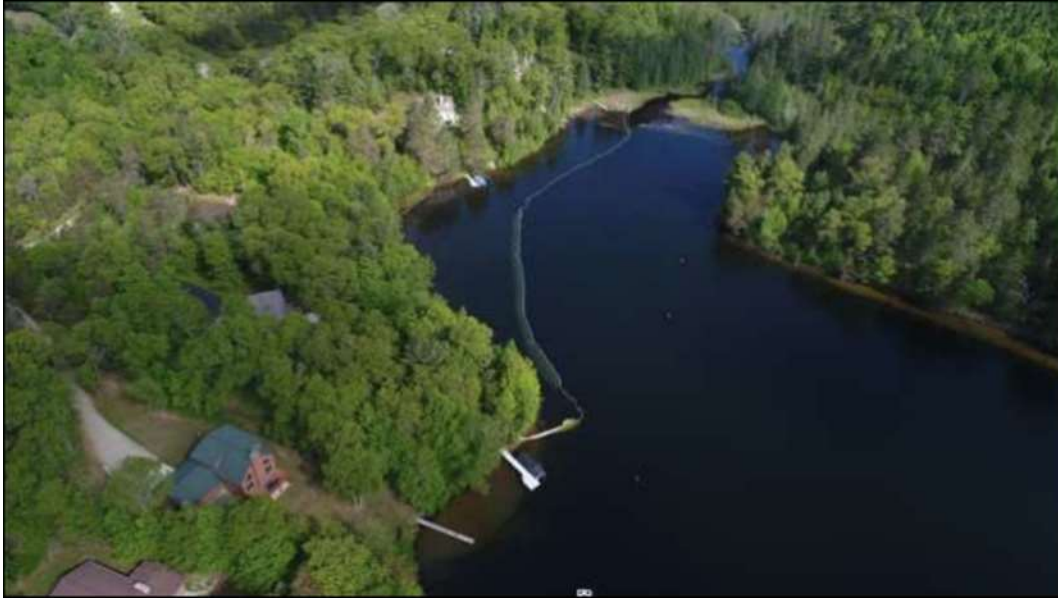
Figure 38: Limno-curtain installed on Thunder Lake (photo from Marinette Co. LWCD)

Small-scale herbicide applications can be made more effective by installing a limno-barrier or curtain around a treatment area to help hold the applied herbicide in place, longer. By doing so, the herbicide/target species contact time is increased. The curtain is generally a continuous sheet of plastic that extends from the surface to the bottom of the lake (Figure 37). The surface edge of the curtain is generally supported by floatation devices. The bottom of the curtain is held in place by some form of weighting. The curtain or barrier, sometimes thousands of feet of it, is installed around the proposed treatment area with the purpose of holding the herbicide in place longer by preventing dilution and drift away from the treated area (Figure 38).

In the Thunder Lake, Marinette County limno-curtain trial completed in 2020, a curtain was installed around two small areas (0.9 and 2.9 acres) of dense growth EWM prior to chemical treatment. Liquid 2,4-D was applied at 4.0ppm inside the barrier. The barriers stayed in place until 48 hours after treatment. Herbicide concentration testing (see following section) was completed within the treated areas to determine how long the herbicide stayed in place and at what concentration. Figure 39 reflects what happened to the herbicide that was applied. Herbicide concentrations stayed relatively high for a longer period of time (48 hrs). Once the curtain was removed, the herbicide dissipated rapidly.

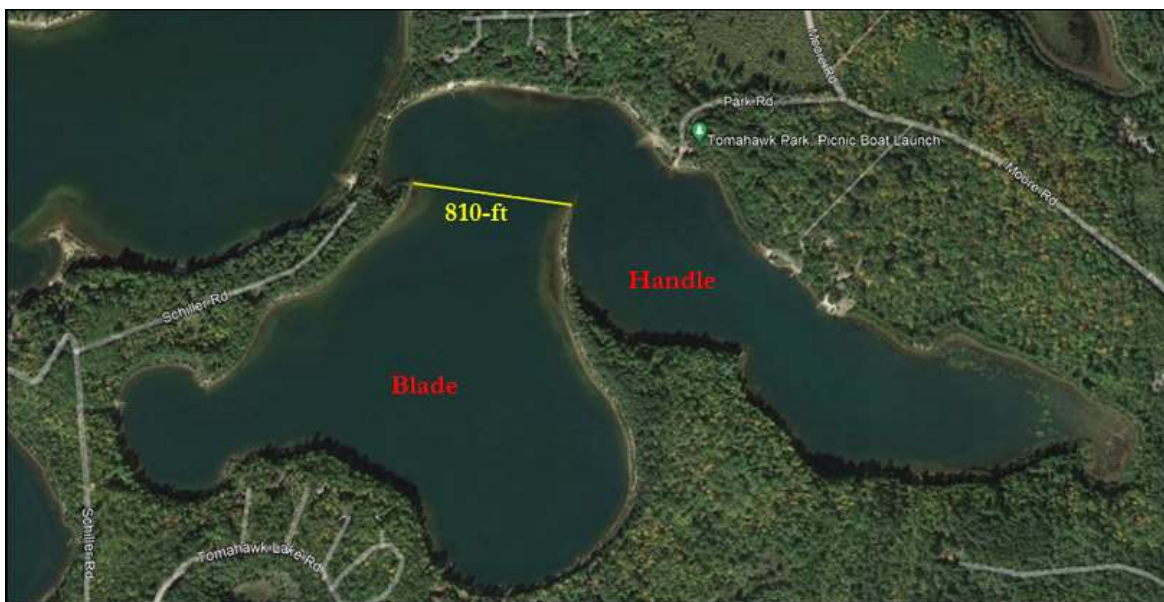
Figure 40: Tomahawk Lake – blade versus handle

into two different basins (yellow line in Figure 40) that would require less than 1000-ft of curtain to complete. A curtain placed at this location would divide Tomahawk Lake into two approximately 63-acre basins. The curtain that has been built by the Eau Claire Lakes Conservation Club is up to 1000-ft long and hangs into the water down to 20-ft, more than enough to get below the established thermocline. In order to improve the efficiency of a whole-basin treatment in the handle area of the lake, the curtain would only need to be in place for 2 or 3 days. The difficulty in installing and removing the curtain would be minimized as it is a straight line, and would not have to be moved in order to affect a successful treatment.

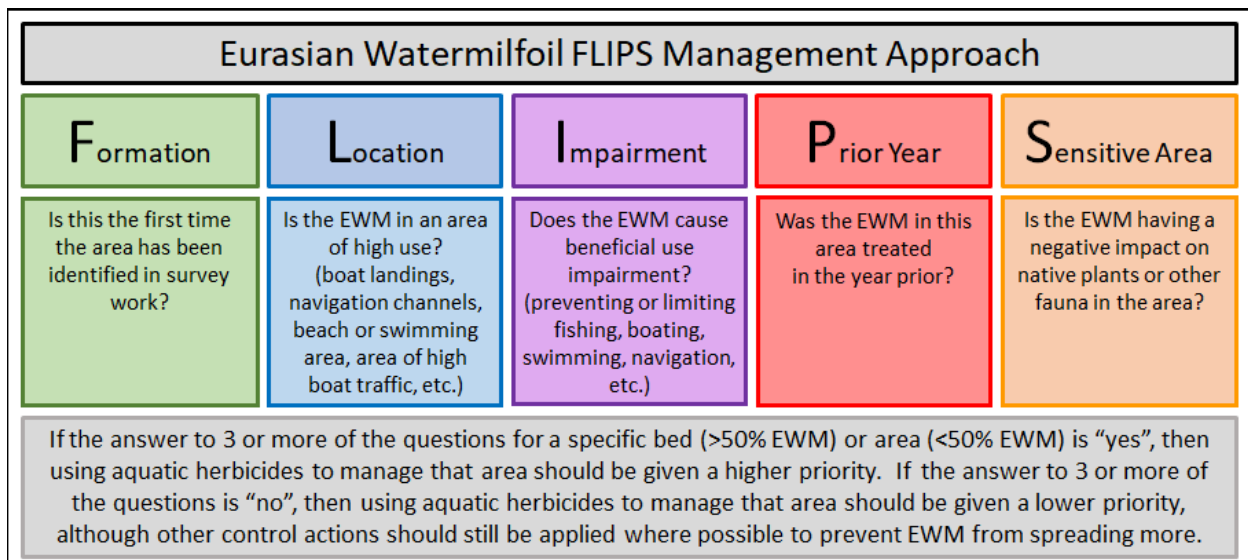
Figure 43: FLIPS Management Priority Matrix

Figure 43 provides a method to determine priority. Referred to as **FLIPS**, it involves evaluating each areas of EWM in the lake in any given year based on when it was first discovered (**F**ormation), where it is located (**L**ocation), whether it is causing use issues (**I**mpairment), whether it was chemically treated in a previous year (**P**rior year), and whether it is negatively impacting the native aquatic plant community (**S**ensitive area). When evaluating a potential treatment area, the five questions in the FLIPS figure should be asked. If the answer to 3 or more of the questions is “yes” then herbicide use can be considered a priority. If the answer to 3 or more of the questions is “no” then herbicide use should not be considered a priority.

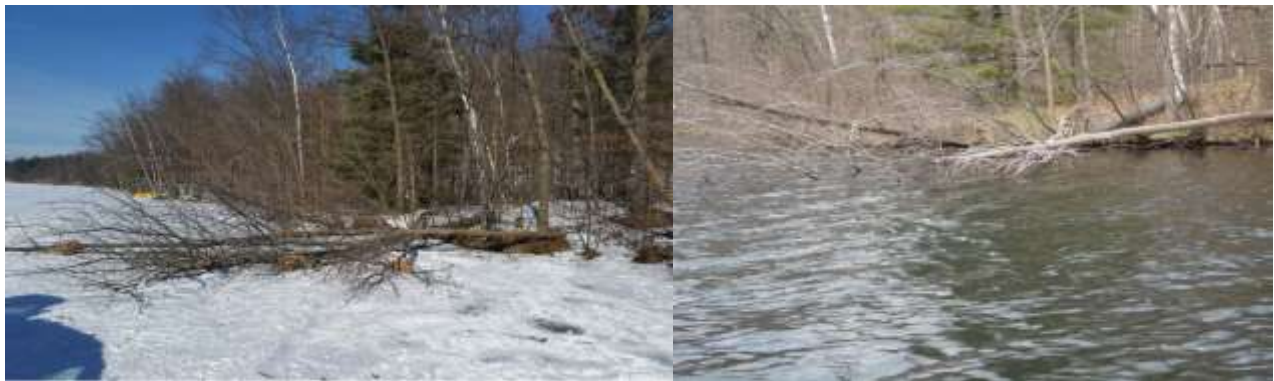
Figure 45: Fishsticks installation (left) and after ice out (right)

Fish Sticks involve taking trees from the inland area of the lake, and installing them in the lake to mimic shore trees that will eventually fall into the lake (Figure 45). The trees used must be taken from a minimum of 35 feet inland and are then secured to the shore with cables for approximately 3 years. This provides habitat for fish, birds, and many other animals. In addition to providing habitat, fish sticks help protect the shoreline from bank erosion. Fish sticks project costs range anywhere from \$100 to \$1000, averaging about \$500. These are very low maintenance because it is only necessary to occasionally check the cables to ensure they are secure. Despite the presence of abundant “standing” trees along the shore due to high water, adding larger trees that reach out past this area, would benefit lake habitat even in periods of lower water.
